COLORADO COUNTY COURTHOUSE MASTER PLAN

Columbus, Texas

VOLZ & ASSOCIATES, INC.

VA Project No: 013-07
September 14, 2007

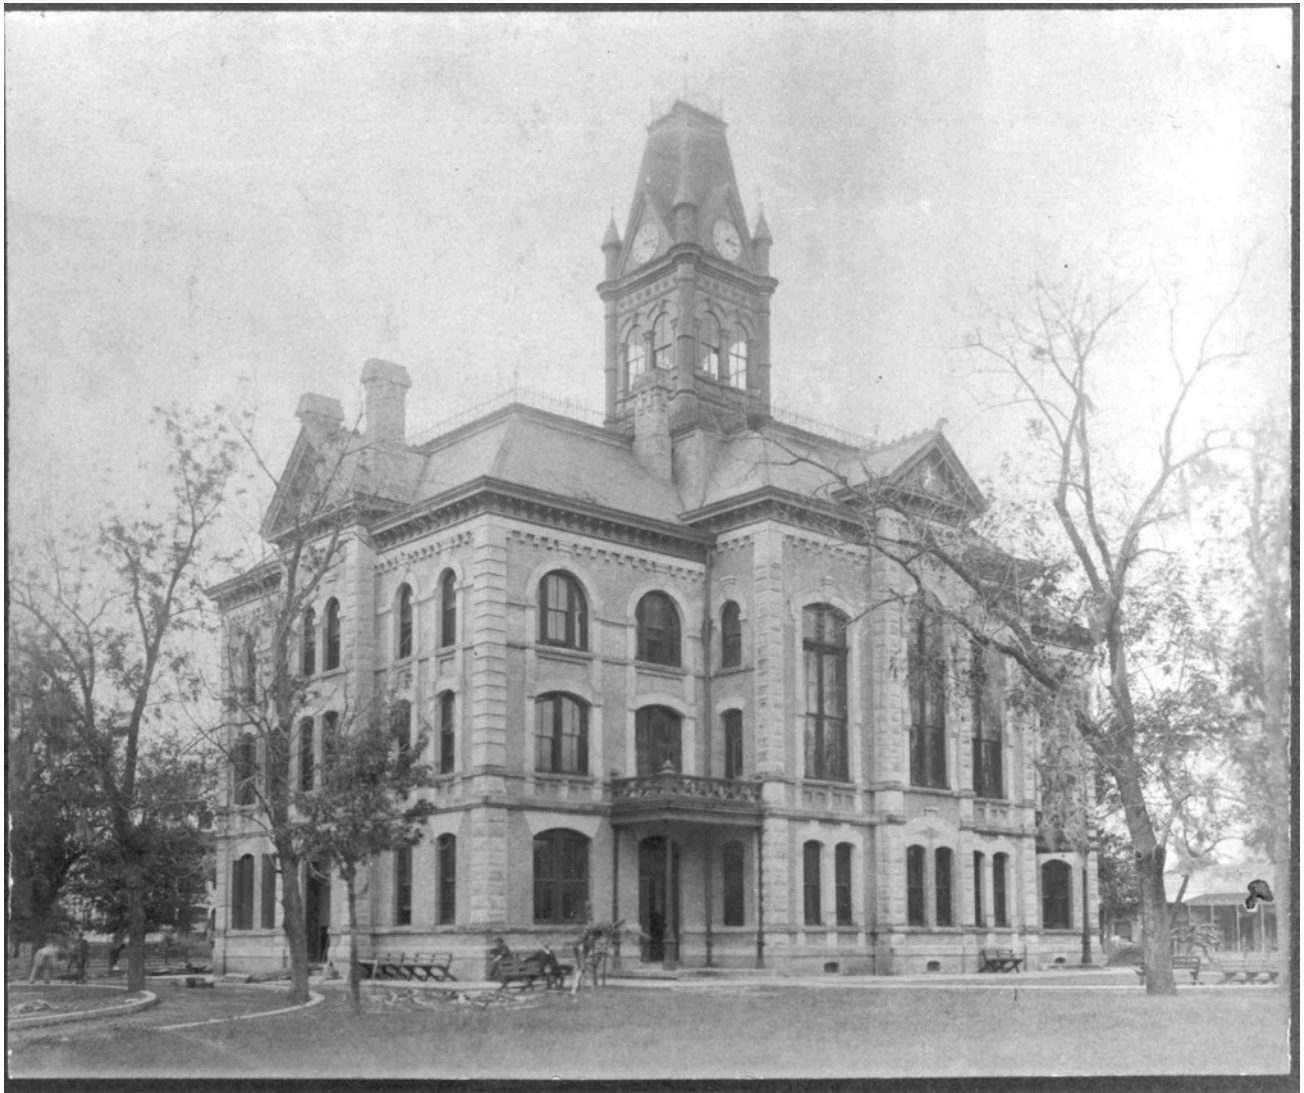
Historic Photo 6: Colorado County Courthouse, c. 1900, photographed from the northwest corner of the square (Original photograph in Big Pictures Box 1 File 21)

Comments: view is from northeast corner
shows original tower, roof form, cornice, clock face, and roof cresting
shows original balcony railings at porches
shows semi-circular drive at east side (possibly under construction)
